## **Northern Sites Saddle Dam Sites**

## SITES SADDLE DAMS LOCATION & GEOLOGIC MAP OF THE NORTHERN SITES SADDLE DAM SITES

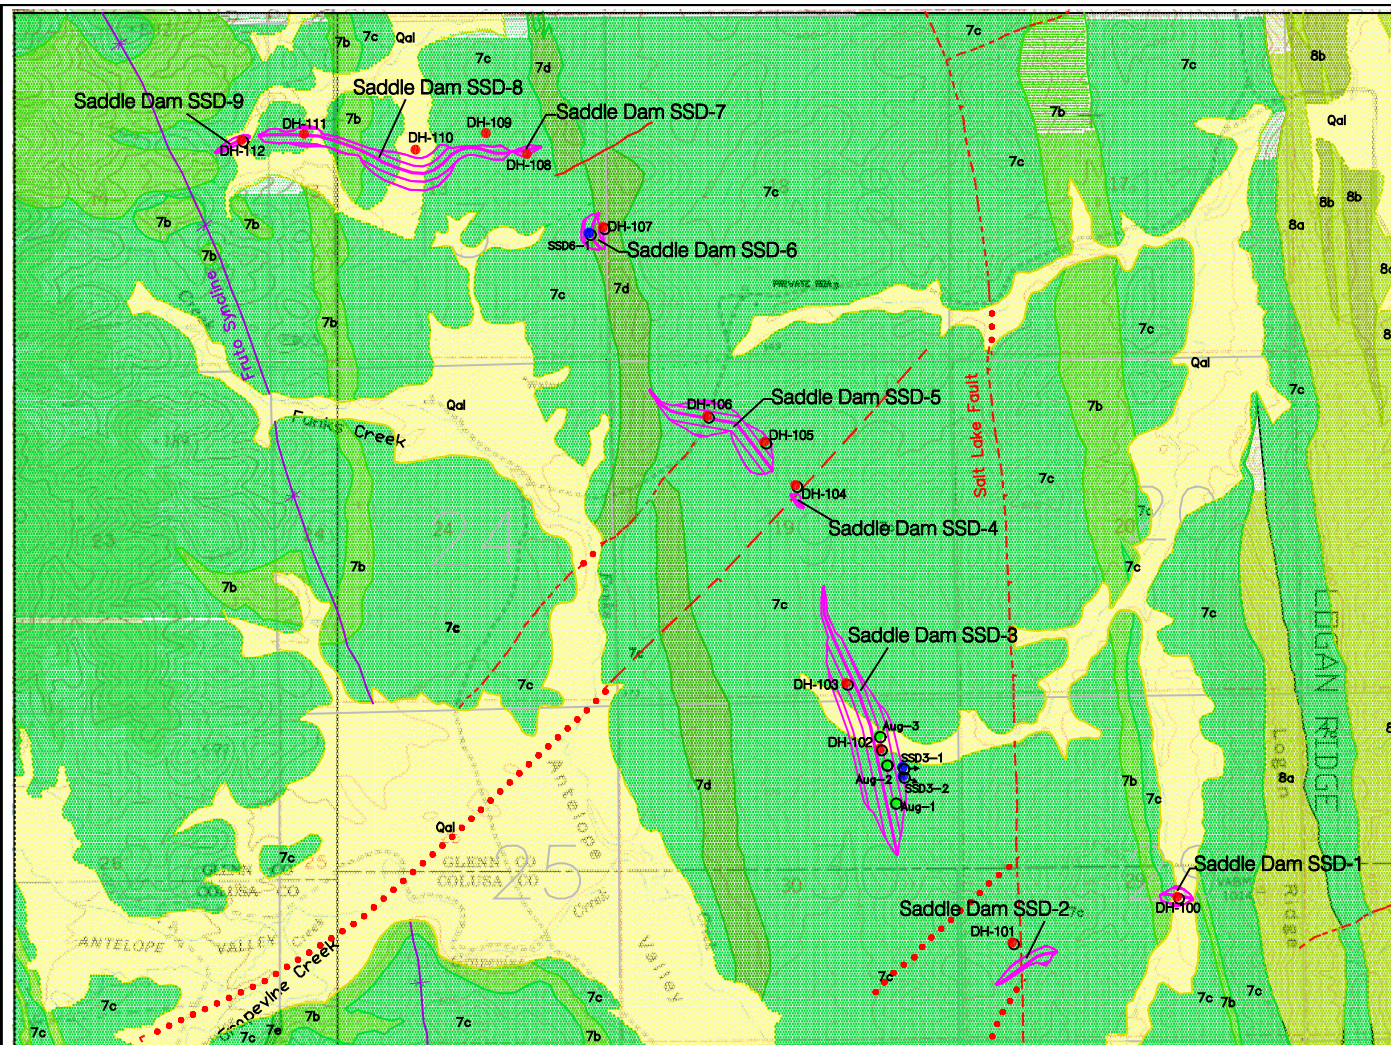
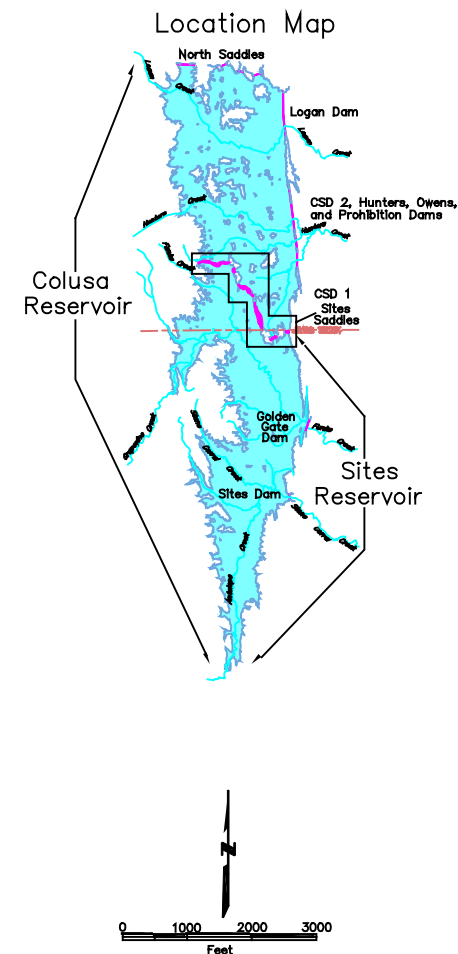
Folding and faulting is evident in the area of the saddle dams (Figure 7). At least three southwest-northeast trending right-lateral faults have been mapped at several locations (Calif., Glenn and Colusa Counties 1961). One crosses the ridge between SSD-6 and SSD-7, another through the SSD-6 axis, and the third through the small SSD-4 site. It is possible that unmapped minor tear faults exist that parallel these features. Beds have an apparent strike slip offset as much as 500 feet by some of these faults. A syncline is mapped to the west of the northern saddle dam alignments of SSD-8 and SSD-9. Instability occurs in the form of soil slips and shallow landslides throughout the general area.

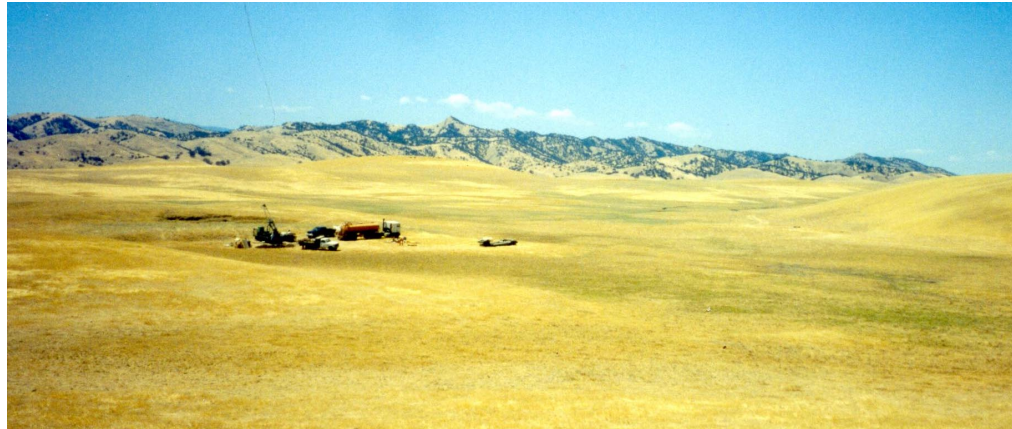
DWR angle drill hole SSD3-1 was drilled at a 45-degree angle to evaluate the stability of the Boxer Formation as foundation rock for Sites saddle dam number 3. It was also oriented to explore the possibility that an unmapped portion of the Salt Lake fault (three-quarters of a mile east) zone may pass through the footprint of the proposed dam. It was drilled to a total depth of 165.0 feet. It drilled through a clayey colluvial soil overburden to 7.0 feet. From 7.0 to 160.5 feet, it drilled through 60 percent sandstone with 40 percent mudstone interbeds. No significant shearing was encountered. The hole was not water pressure tested because of difficulties testing this angle hole. DWR angle drill hole SSD3-2 was drilled at a 45-degree angle to further explore the possibility that an unmapped portion of the Salt Lake fault zone may pass through the footprint of the proposed dam. It encountered 60 percent sandstone with 40 percent mudstone interbeds to the bottom of the hole. Again no significant shearing was encountered. Calculation of RQD's for both holes showed that in general, the foundation should have very poor rock quality from the surface to 20 feet vertical depth, then good to 22 feet. It then will be very poor to 34 feet, then poor to 50 feet, then good to 71 feet, then poor to fair to 80 feet (Table 17). This hole was not water pressure tested because of difficulties testing this angle hole.

**Photo 28. CME-850 drill rig at angle hole SSD-3 at northern Sites saddle dam number 3**

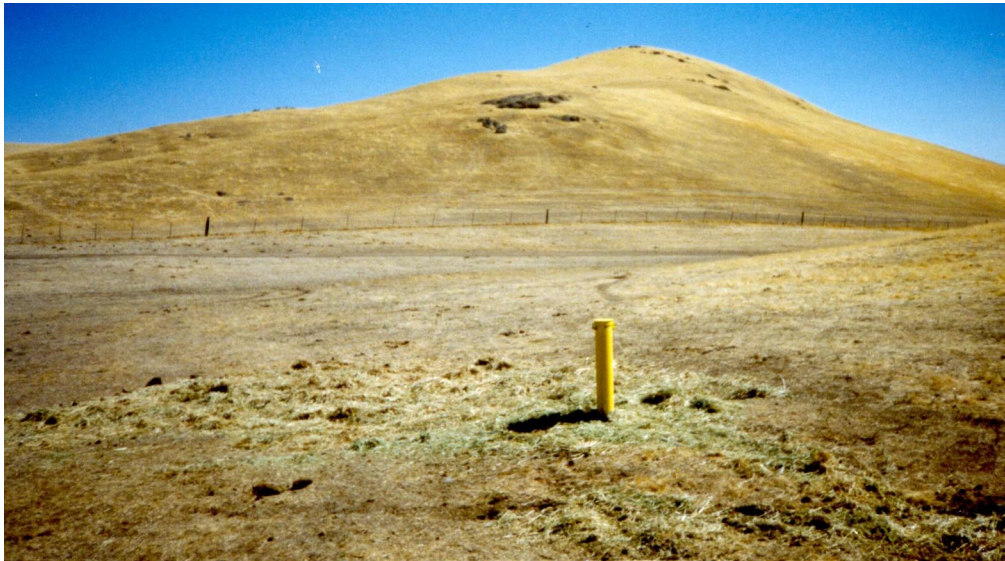
Vertical DWR drill hole SSD6-1 was drilled to evaluate the engineering characteristics of the conglomerate as foundation rock for saddle dam number 6 (Photo 29). It was drilled to a depth of 119.0 feet. It encountered a clayey colluvial soil from 0 to 9.2 feet. From 9.2 to 16.1 feet, it drilled through 100 percent sandstone. From 16.1 to 119.0 feet, it drilled through 75 percent conglomerate

with 25 percent sandstone interbeds. Water pressure testing indicated that the conglomerate rock is very tight. Permeabilities in this zone average 1.73 feet per day.

**Photo 29. DWR drill hole SSD6-1 at Sites saddle dam site number 6**

Additional geological exploration is recommended. Another hole should be placed upstream of the proposed dike to further evaluate the permeability of the massive conglomerate and sandstone.
